RESEARCH MEMORANDUM

CYCLIC ENGINE OPERATION OF CAST VITALLIUM TURBINE BLADES

AT AN EXHAUST-CONE GAS TEMPERATURE OF $1440 \pm 20^{\circ} \text{F}$

By Charles Yaker and Floyd B. Garrett

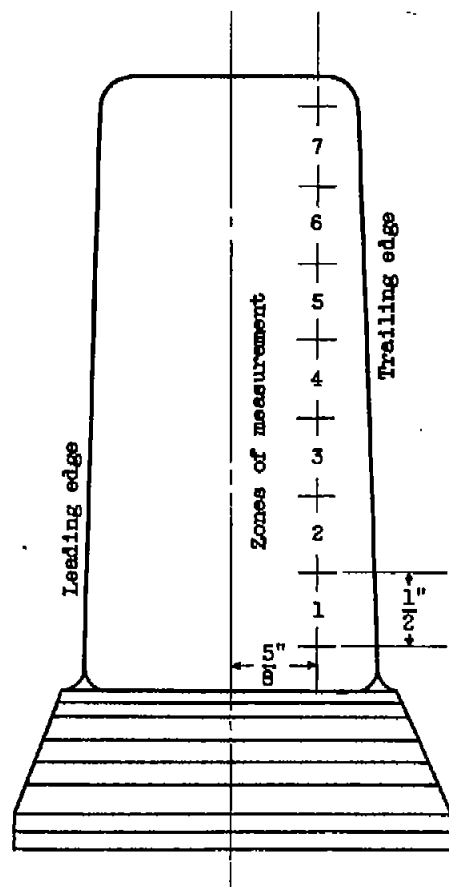
A determination of the amount of elongation in turbine blades is of importance in correlating performance in the engine with existing design data. In order to determine the amount of blade elongation, five blades were scribed, as shown in figure 1(a), and measurements made between these marks. This number of blades, which were spaced at random in the rotor, was selected to give a representative sample of the entire turbine rotor. The gage marks were scribed near the trailing edge of the blades to allow measurement without removing the turbine rotor from the engine. The measurements were made by means of an optical extensometer reading to ± 0.005 inch. In order to determine the amount of turbine-wheel elongation, scribe marks were placed at 1/2-inch intervals along two diameters at right angles to each other on the exhaust side of the rotor.

(a) Scribe marks on convex side of turbine blade for use in measuring elongation.

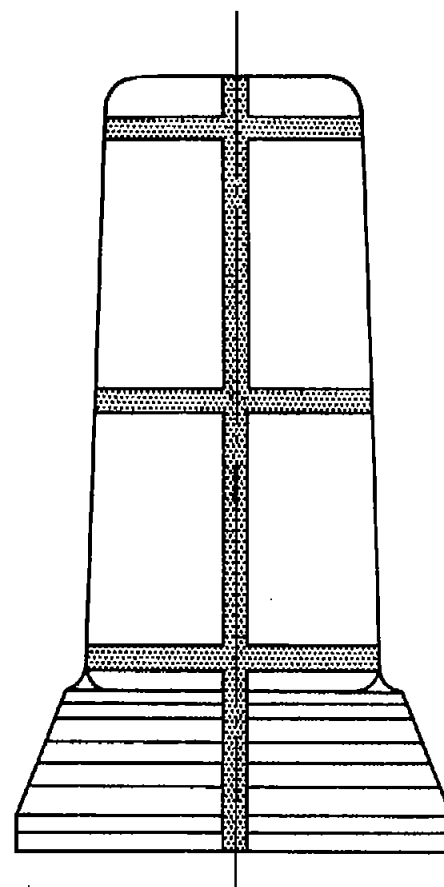
Hardness surveys. - Hardness measurements were made on a hardness tester of the indentation type, using a major and a minor load applied by a loaded lever system. The load of 150 kilograms was applied to a spheroconical indenter (Rockwell C). The hardnesses of all the broken blades and the five scribed blades were determined from base to tip along the center and from the leading to trailing edge at the base, the middle, and the tip of the airfoil section. The zones of the hardness surveys are shown in figure 1(b).

(b) Zones of blade (shaded areas) where Rockwell C hardness measurements were made.

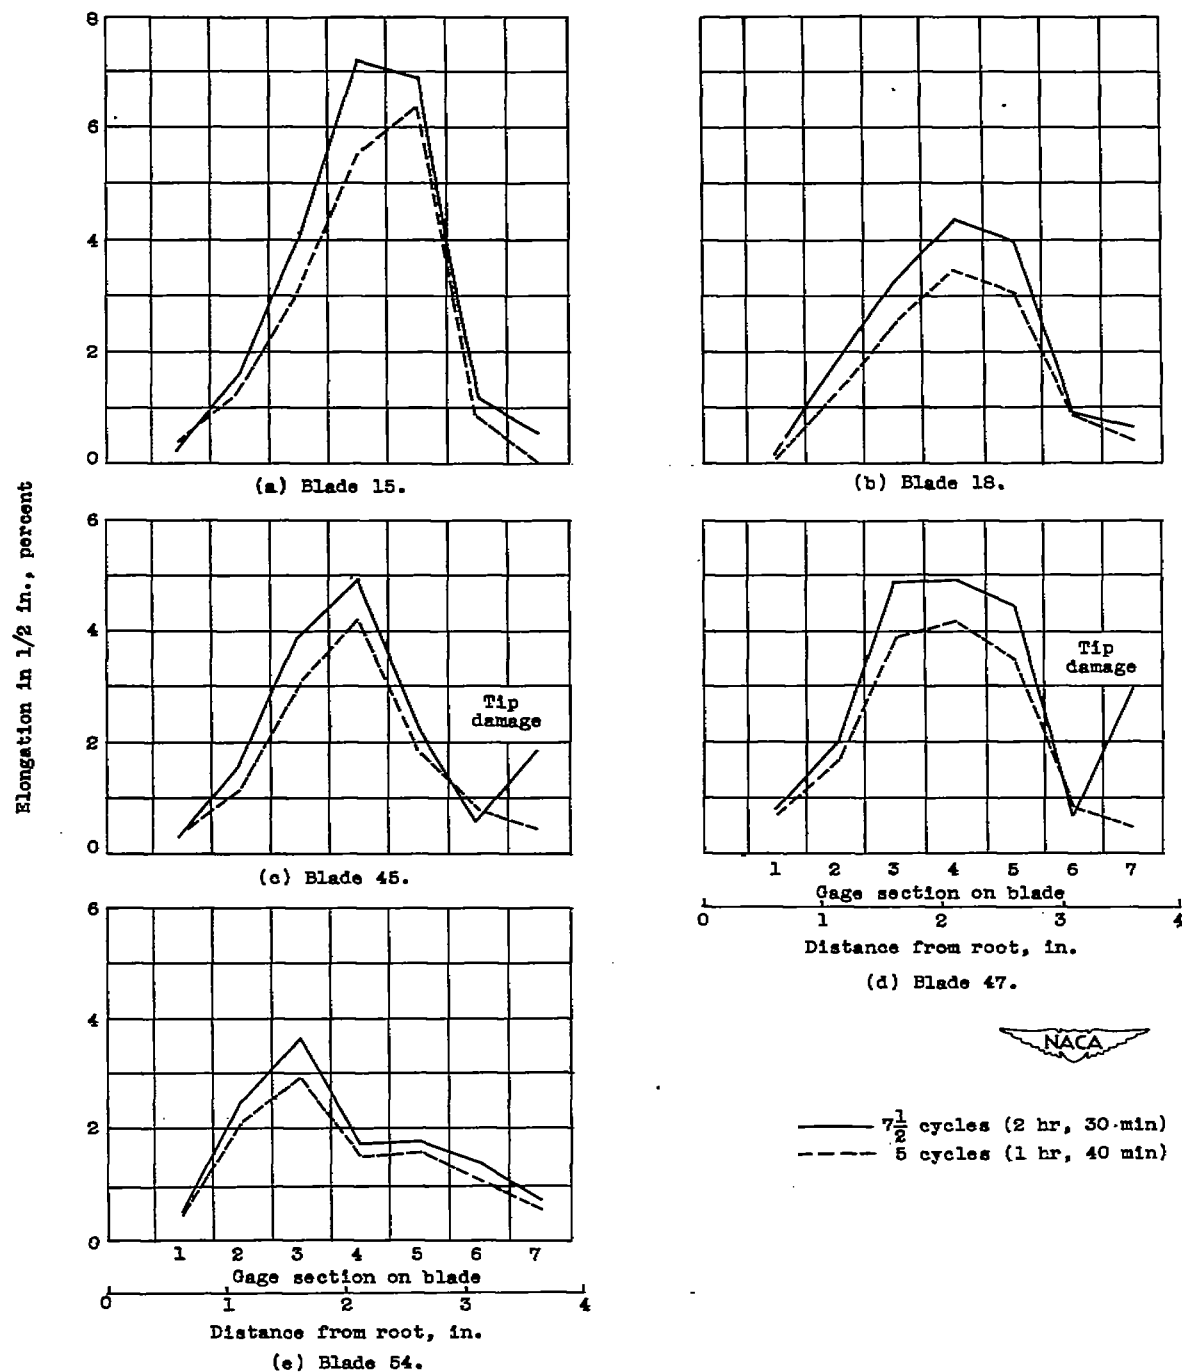
Final elongation measurements were made and plotted with the measurements made at the end of the first 5 cycles (1 hr, 40 min) as percentage elongation in each $1/2$ -inch-gage length, as shown in figure 5. Total blade elongations were determined and are presented in table II. The over-all blade elongations after $7\frac{1}{2}$ cycles range from 1.50 to 2.71 percent. From the elongation distributions, it can be seen that the largest portion of the blade elongation (2.37 to 6.04 percent) occurs in the section $1\frac{3}{8}$ to $2\frac{7}{8}$ inches from the top of the blade root. A comparison of the elongation in this section with the total elongation is also presented in table II. This comparison indicates that approximately 60 to 84 percent of the total blade elongation occurs in this zone.

Figure 5.- Variation in elongation along airfoil section of blade plotted at midpoint of gage section.

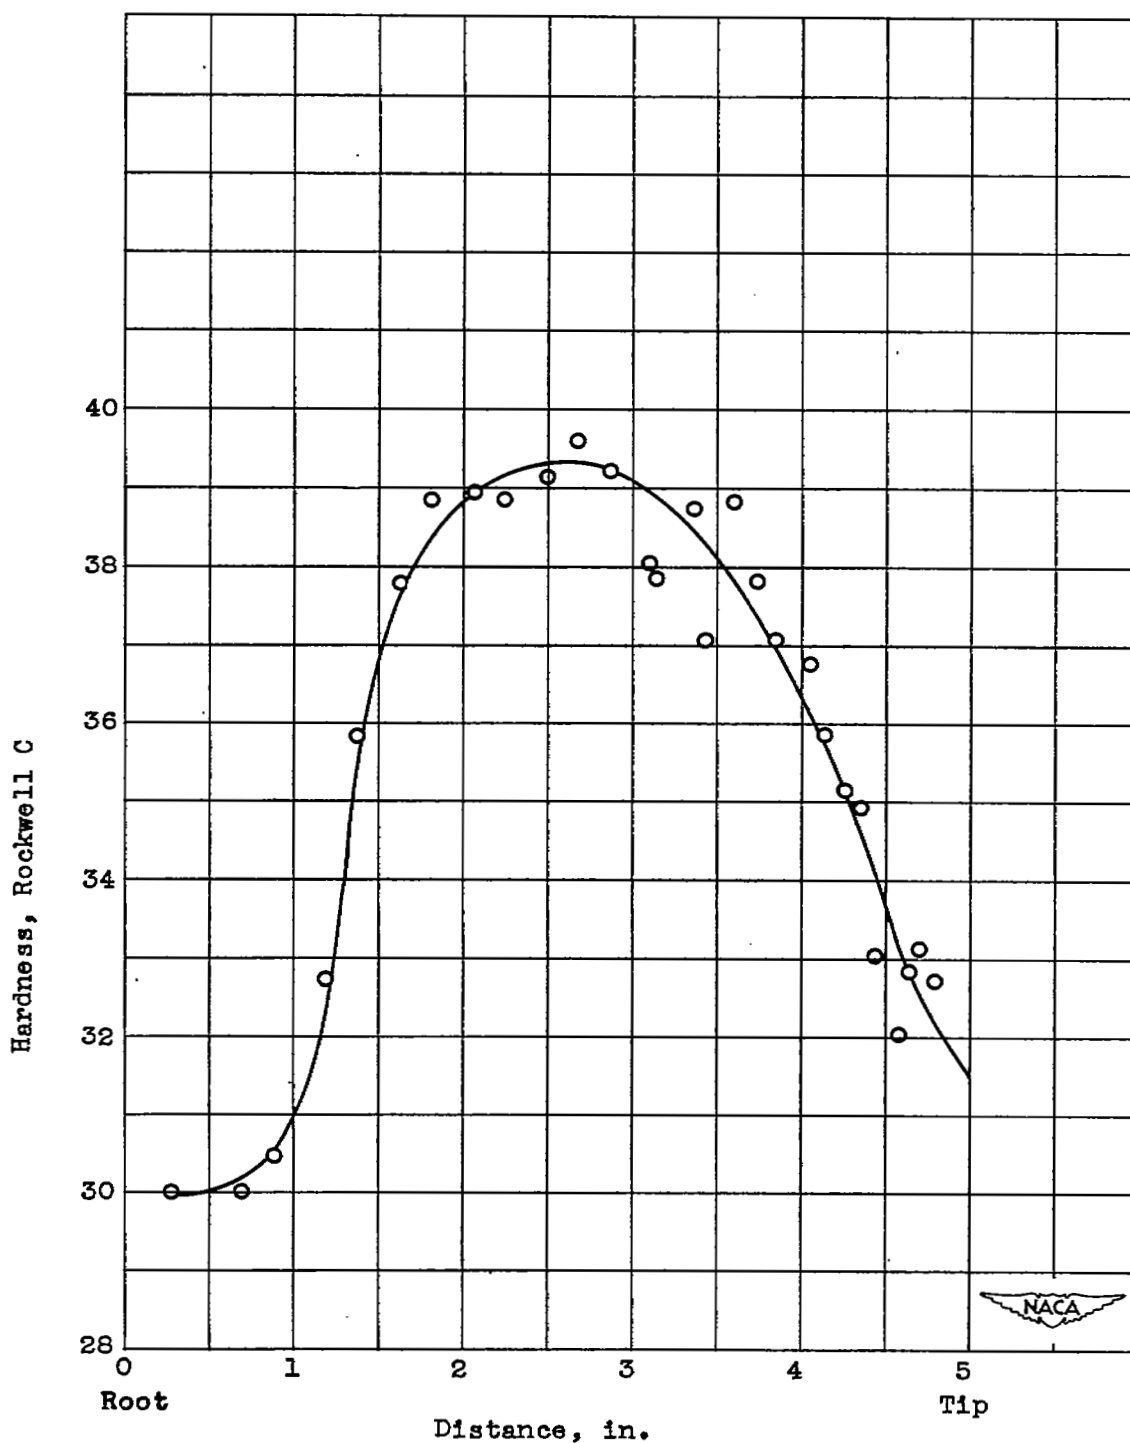
Hardness surveys. The hardness distributions throughout the broken, cracked, and the five unbroken and scribed blades are given in table IV. A typical spanwise hardness distribution along the center of a blade is shown in figure 7. All Rockwell C hardness values

The results of the hardness surveys yielded no correlation between blade failure or elongation and hardness. The hardness variation along the blades (fig. 7) is an indication of the combined effects of stress and temperature distribution in strain and age-hardening the blades during operation.

Figure 7. - Typical hardness distribution along center of blade. (Data points are average hardness values.)
